TANAKA FAMILY'S HOUSE

09/07/2026

## IDENTIFICATION OF STRUCTURAL DEFECTS

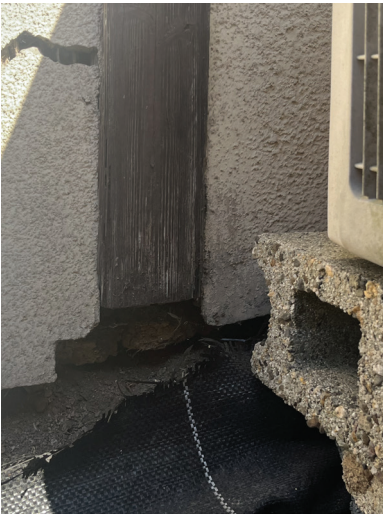
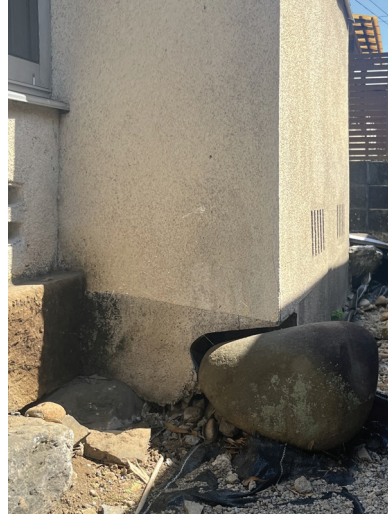
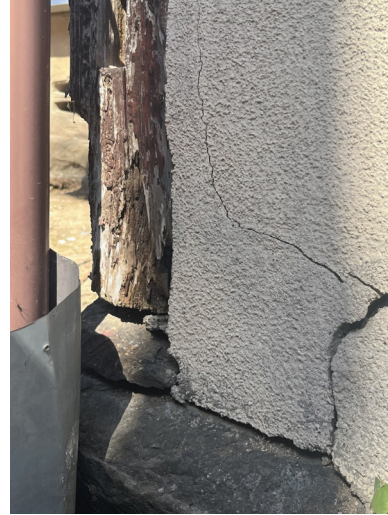
Ground movement has altered the load distribution, causing the column to separate from its stone foundation. Consequently, the column is no longer transferring its load to the foundation stones.

Reconstruct the foundation beneath the column to restore stable and continuous support. The foundation shall bear on competent, well-compacted ground. The foundation stone should be properly seated, with adequate embedment, or replaced with a concrete footing if required by the ground conditions. A geotechnical assessment of the soil is recommended to verify its bearing capacity and identify any causes of ground movement. The installation of a perimeter drainage system should be considered to reduce moisture ingress, and the foundation should be inspected and repaired where necessary.

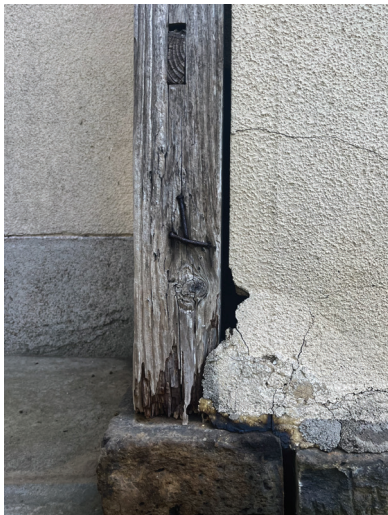
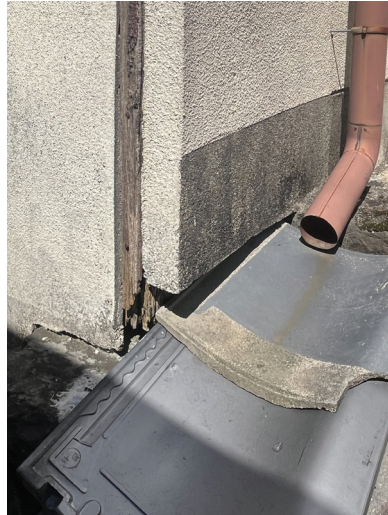
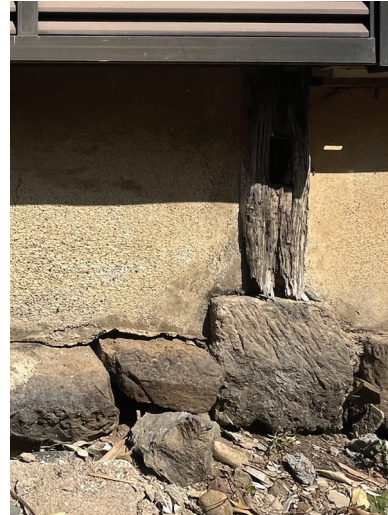
The timber column base has deteriorated as a result of rising damp.

Replace the deteriorated lower section of the timber column with a new timber section, avoiding the need to replace the entire column.

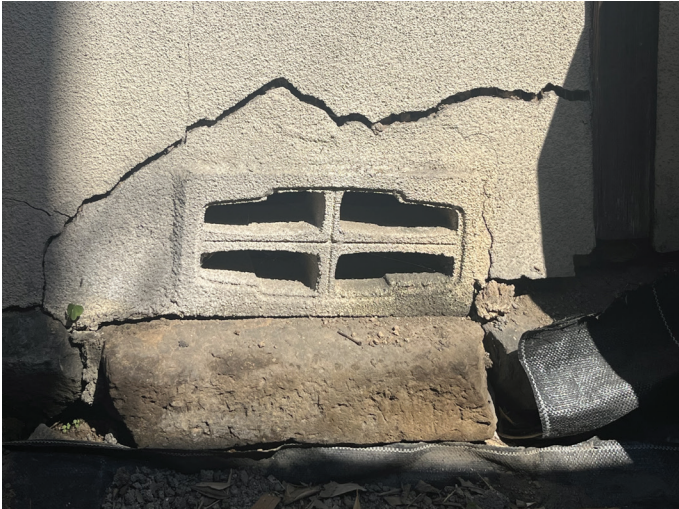
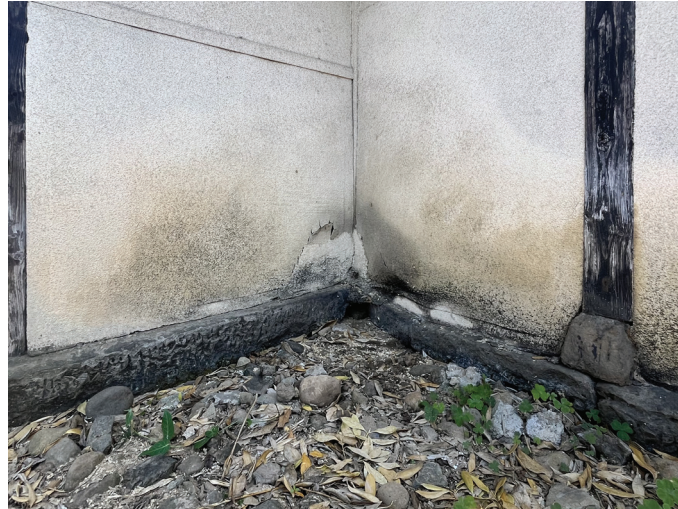
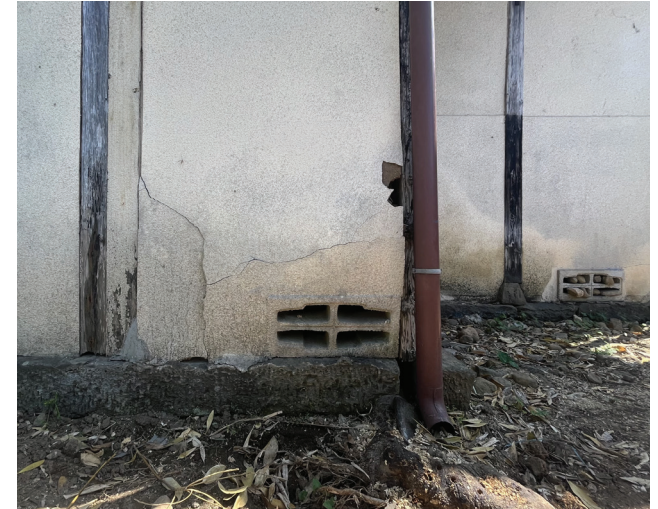
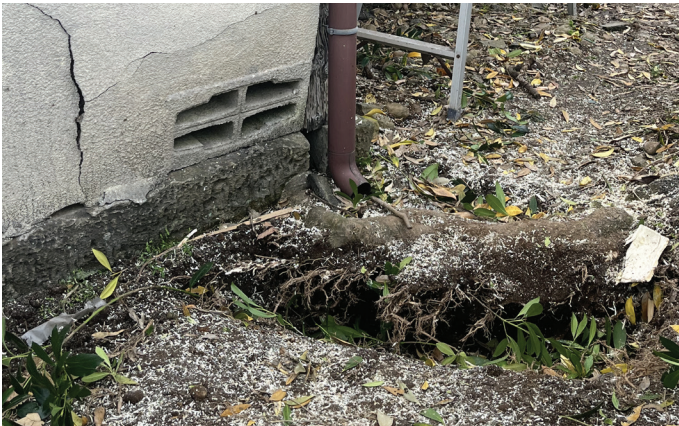
## CEMENT RENDER DEFECTS

The roots of the nearby tree may have exerted pressure on the foundations or the base of the wall, leading to the formation of cracks in the wall sections. These cracks may then have allowed rainwater to infiltrate the cement render. Repeated moisture exposure, combined with the building's corner configuration and its north-facing orientation, may have created favourable conditions for biological (fungal) growth.

Remove and replace the damaged cement render with a natural lime-based render. Lime render is more vapour-permeable, allowing trapped moisture to evaporate and reducing the risk of further deterioration.

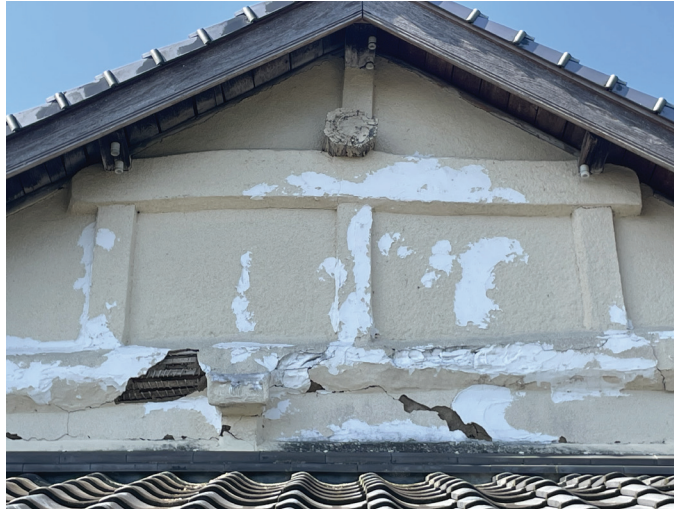
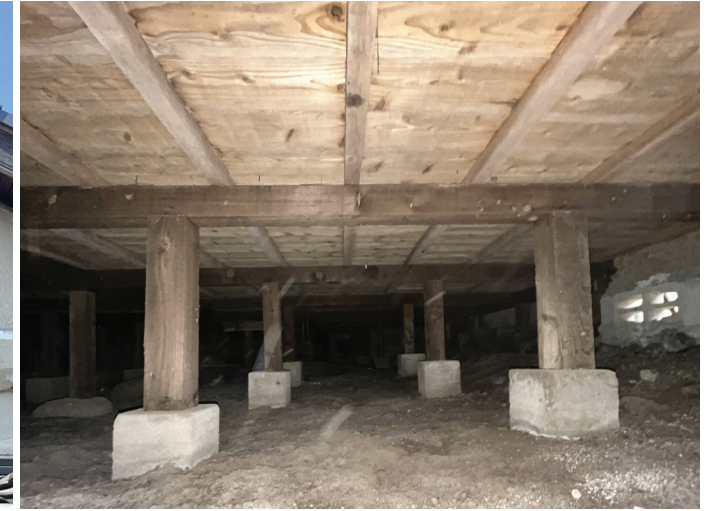
## ADDITIONNALS COMMENTS

The main cause of deterioration appears to be the presence of a cement-based render on the façade. Unlike traditional lime render, cement render has low vapour permeability and prevents moisture from evaporating naturally. As a result, moisture becomes trapped within the walls and is transferred to the adjacent timber elements, particularly the bases of the columns, accelerating their deterioration.

The other defects observed, including moisture staining, biological growth, deterioration of the render and timber columns, as well as localized foundation movement, appear to be direct or indirect consequences of this persistent moisture. These conditions may also have been aggravated by water ingress, inadequate drainage, or ground movement.

The timber floor structure appears to be generally sound, with no significant defects observed. The accessible crawl space also offers the opportunity to install underfloor insulation in the future to improve the building's thermal performance, provided that adequate ventilation is maintained to prevent moisture build-up.

The priority should therefore be to address the sources of moisture before carrying out repair works. Replacing the cement render with a traditional lime-based render, which is better suited to this type of historic building, is a key measure to ensure the long-term durability of the repairs.
